Canadian Brownfields Case Study

New Calumet Mine Remediation

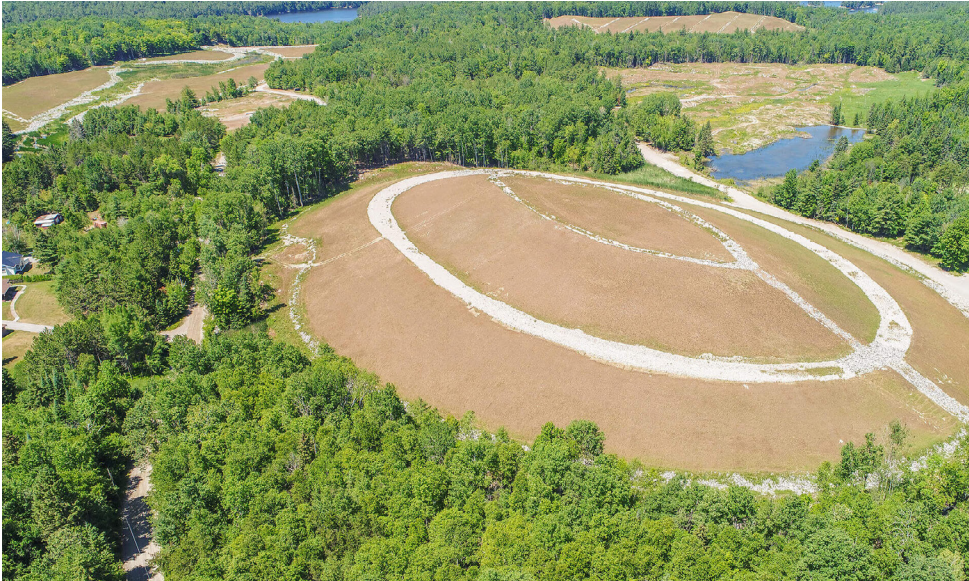
Tailings ponds Area A, B and C fully remediated at the former New Calumet mine site. To the left is Area A, in the middle is Area B and in the far right corner is Area C. The Ottawa River can be seen behind the remediated site.

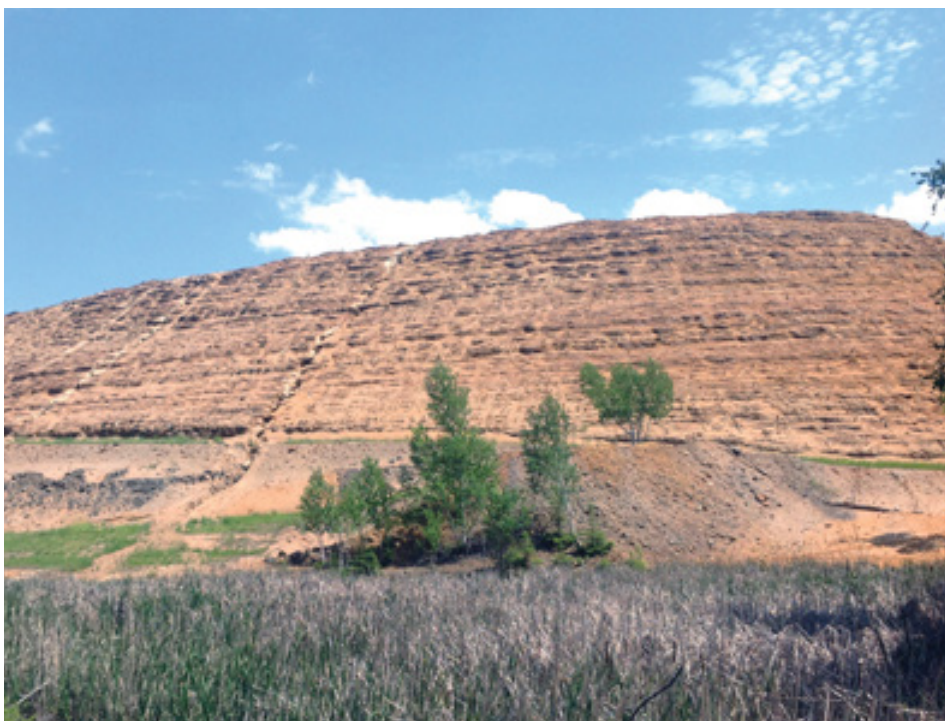
Area B, the tallest waste pile on site, was leveled and moved to Area C during the early stages of remediation.

Once approved, the remediation of the site began with transferring some of the waste material from Area B - which was approximately 90 feet tall at

its peak - to Area C. Both site's tailings were leveled in order to receive the geosynthetic clay liner. In order to cover the tailings and prevent windblown dispersion. Once the excess tailings were transferred from Area B to Area C, both tailings ponds were covered with geosynthetic clay liners (GCL) to block oxygen supply and the sites were backfilled with the materials to form a capillary barrier system.

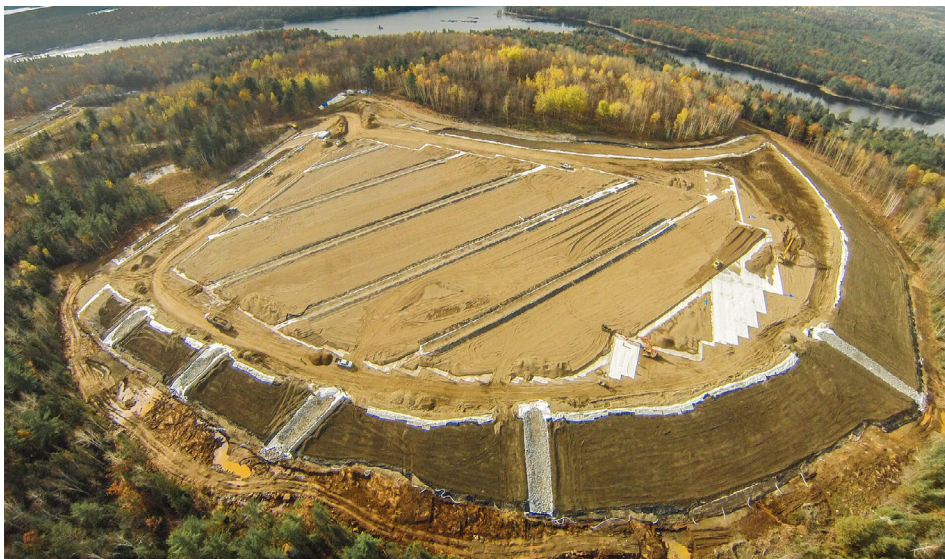
Area B nearing completion. The site has been levelled and geosynthetic clay liner is being backfilled with local silt.

Unstable pillars were taken down and rock material was added to the downstream slope of the creek to increase the stability of the dike. Once the GCL was laid, the sites were backfilled with silt, sand, gravel, repurposed crushed concrete, stone, other granular material and topsoil to support vegetation. There was no direct action plan implemented to address surface and groundwater contamination, however it was argued that remediation efforts would improve

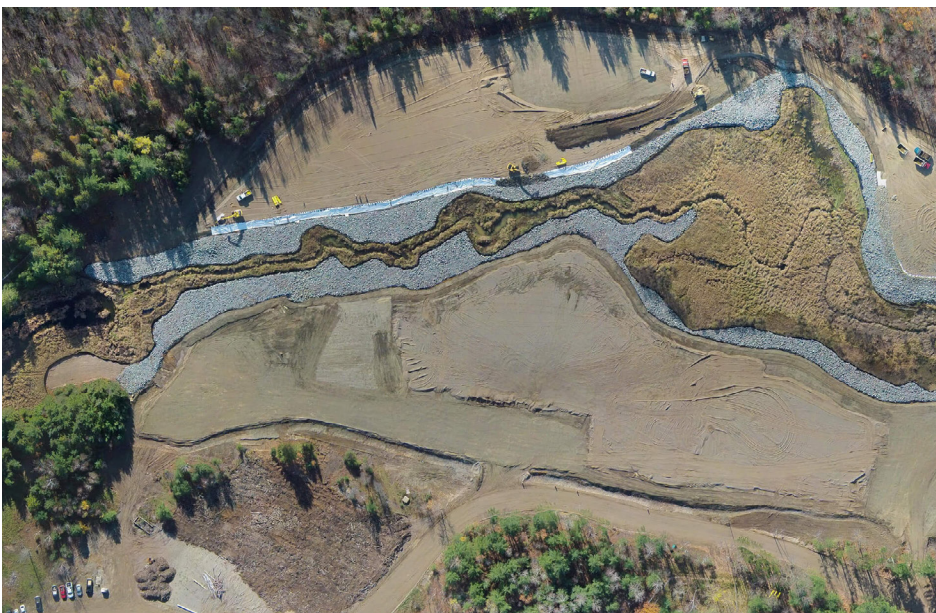
Area A during remediation. The creek and marshland running through the site were protected due to natural filtration and buffering qualities. GCL was brought as close to the shoreline as possible where riprap was installed to prevent any further erosion of this ecologically sensitive area.

Area A was fully saturated with water and required extensive care. A capillary barrier system was also installed to prevent tailings from infiltrating the creek and wetland running through it. Workers had to be very careful to preserve the natural vegetation and active fauna in this area. Since the wetland was acting as a natural filter and erosion barrier, WSP decided to expand it. The geosynthetic clay liner was secured to the new shoreline and riprap was integrated into the natural environment to further prevent erosion and stabilize the area.

The excavation, transport and placement of the silt required for Area A had to be completed in dry conditions which was very difficult given that Area A was completely saturated. Sloped areas presented unique challenges for the transportation of materials and grading of the backfill. Dump trucks equipped with conveyor belts mechanically spread the backfill material over large areas. Area A, being the most ecologically sensitive tailings pond, had already significantly re-naturalized since the mine was decommissioned. In order to preserve the newly re-established vegetation - which also acts as buffer preventing further erosion - WSP expanded the existing swamp and brought the capillary barrier up to the shoreline. They also installed riprap along the shoreline to prevent further erosion.
