Canadian Brownfields Case Study

BC Hydro Rock Bay Remediation Project

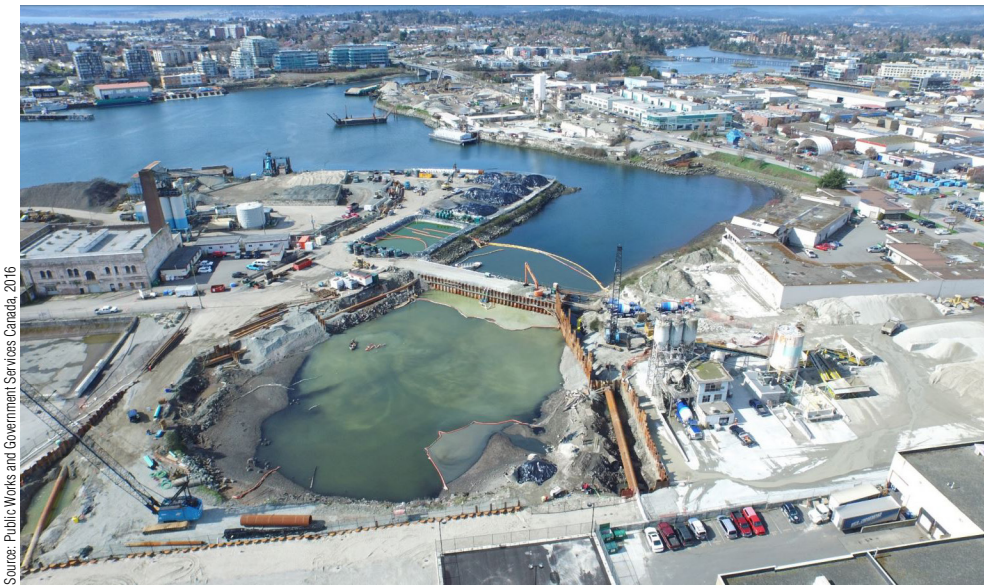
Figure 1. Rock Bay site area during phase 3 of remediation

Stage 3 began in 2013 - 2016 and was done independently; the remediation was continued by Public Works and Government Services Canada (PWGS) on behalf of Transport Canada, while BC Hydro completed the remediation in the upland areas³³. PWGS was in charge of addressing the contaminated materials found within the head of Rock Bay and the adjoining portions that were adjacent to the federal uplands³⁴. In the third stage of this remediation project, BC Hydro focused on the modified sheet pile for further excavation towards the property line as an additional 80,000 tonnes of coal tar was found under the seawater in Rock Bay³⁵. The excavation process was extended to go deeper by 0.5 metres (See Figure 4), removing up to 1 - 2 metres of the underlying clay to diminish the possibility of any residual contamination to affect the post-remediation groundwater quality³⁶. BC Hydro also rerouted and replaced the stormwater discharge pipes in the area due to its proximity to the excavation site³⁷.

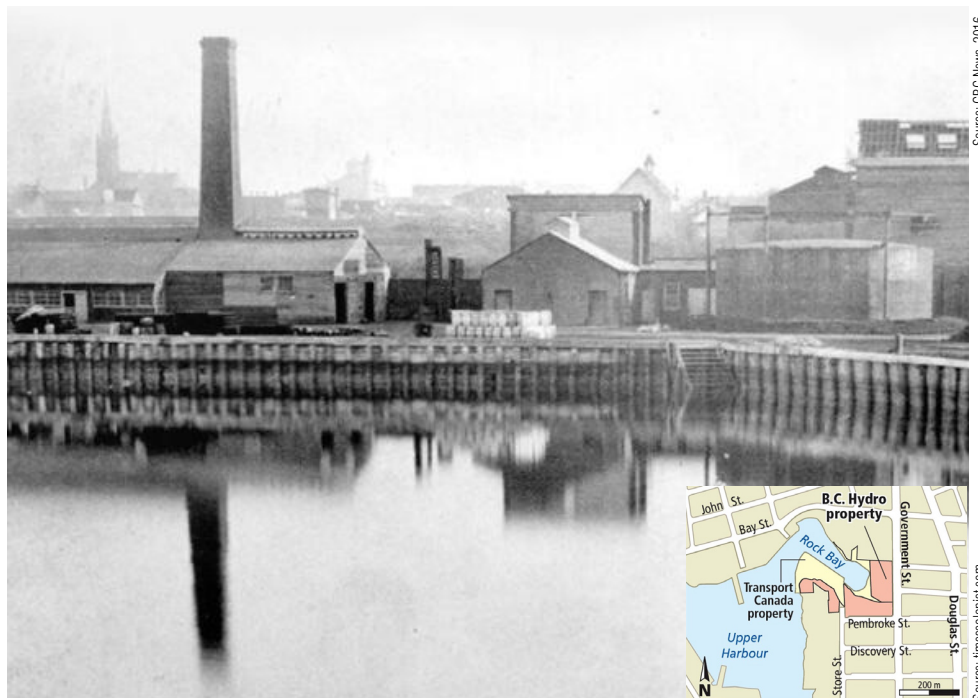
Figure 2. Historical photo of site area from 1862 showing the coal gasification plant with a context map outlining the division of property

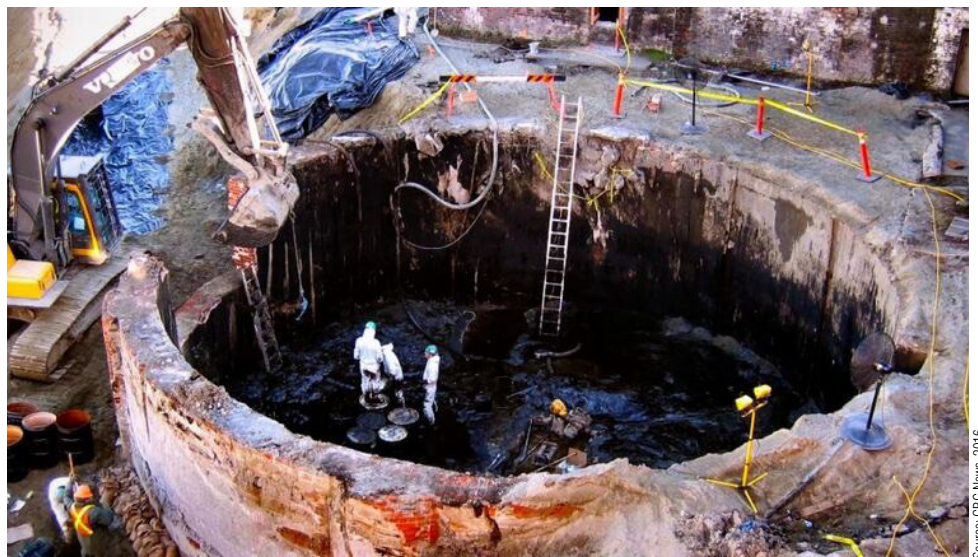
Figure 3. Photo of tar well excavation and clean up process

Stage 1 occurred between 2004 - 2005 where over 110,000 tonnes of contaminated materials from BC Hydro and Transport Canada lands were excavated and disposed of off-site¹⁸. During this excavation phase, a tar well, with a depth of 14 metres, was identified as the source for the contaminated groundwater¹⁹. It was estimated to contain 26,000 litres of coal tar NAPL²⁰. The tar was stabilized in-situ using hog fuel, a type of wood product that consists of bark and wood chips²⁴, to satisfy treatment facility requirements while further options for remediation could be considered²¹.

box, steel caisson shorting, and secant barrier wall²². Ultimately, sheet piles were used where ripraps were not present and in 2013, secant barrier walls were installed around the tar well²³. Soil, brick, and tar were removed from the initial working area and the residue on the secant walls were cleaned (See Figure 3)²⁴.

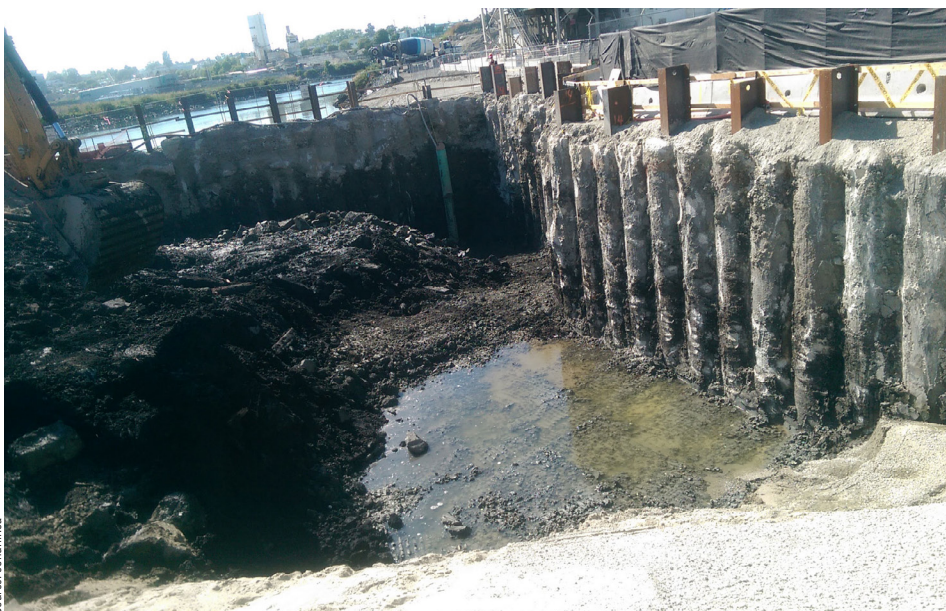
Figure 4. Photo of excavation within the newly installed secant barrier walls

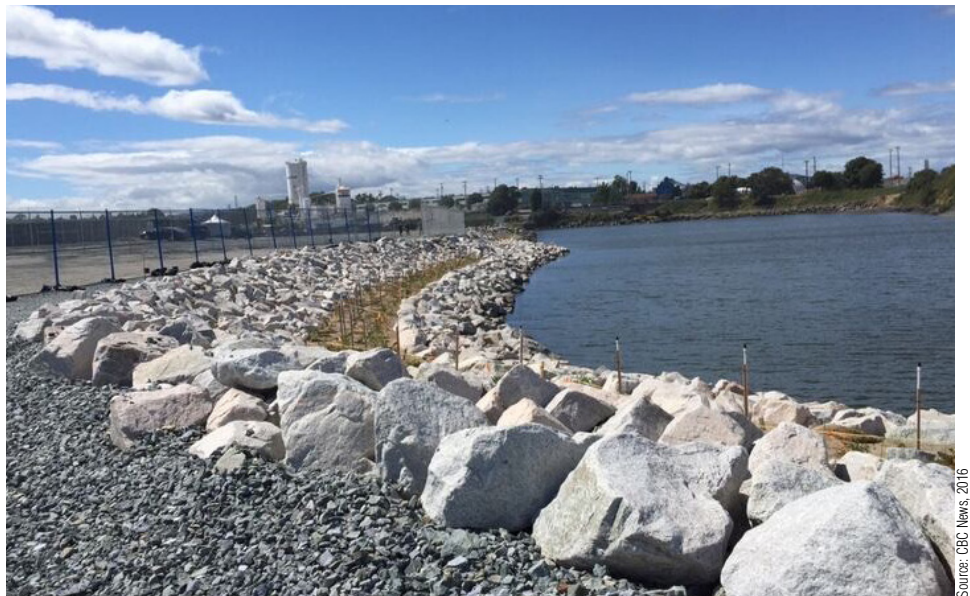
Figure 6. Photo of the remediated harbour at Rock Bay to remove the contaminated sediment

The PWGS focused on removing and remediating 140,000 tonnes of contaminated materials along with building a temporary cofferdam over the contaminated bay in order to seal it and prevent water infiltration from the rest of the harbour³⁸. This section of the project also includes the

building of 300 metres of sheet metal walls around the bay in the uplands area to connect to the cofferdam³⁹. The cofferdam spans over 130 metres and up to 15 metres in depth, and will be removed upon the construction of the temporary support walls and outfall bypasses that will drain into Rock Bay⁴⁰. An on-site wastewater treatment facility was also constructed in order to treat the wastewater that will be returned to the harbour⁴¹.
