# Canadian Brownfields Case Study

## Bata Shoe Factory Redevelopment

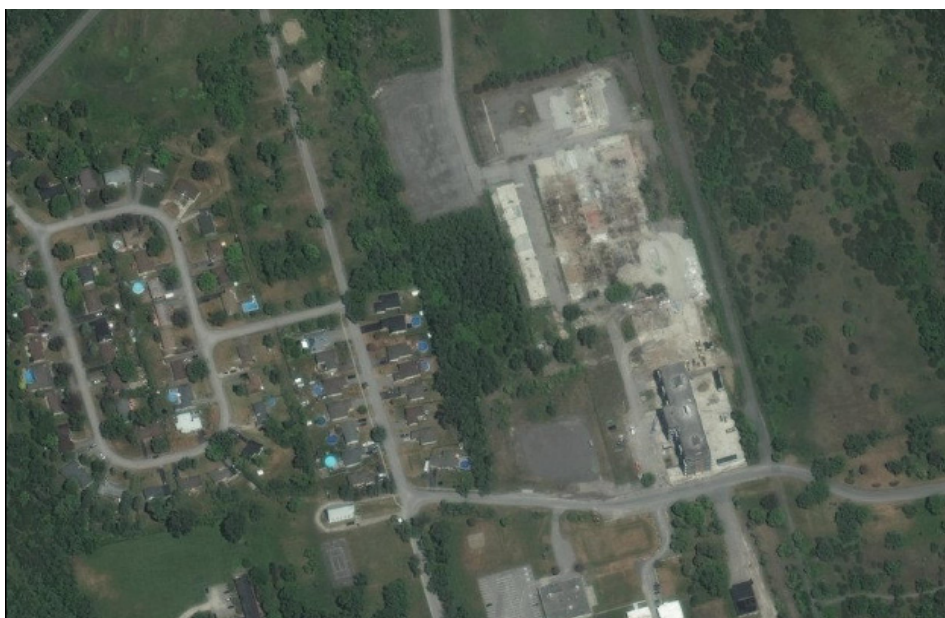
*Aerial Imagery of the Bata Shoe Factory site, showing the community of Batawa to the west and converted rail trail to the east<sup>20</sup>.*

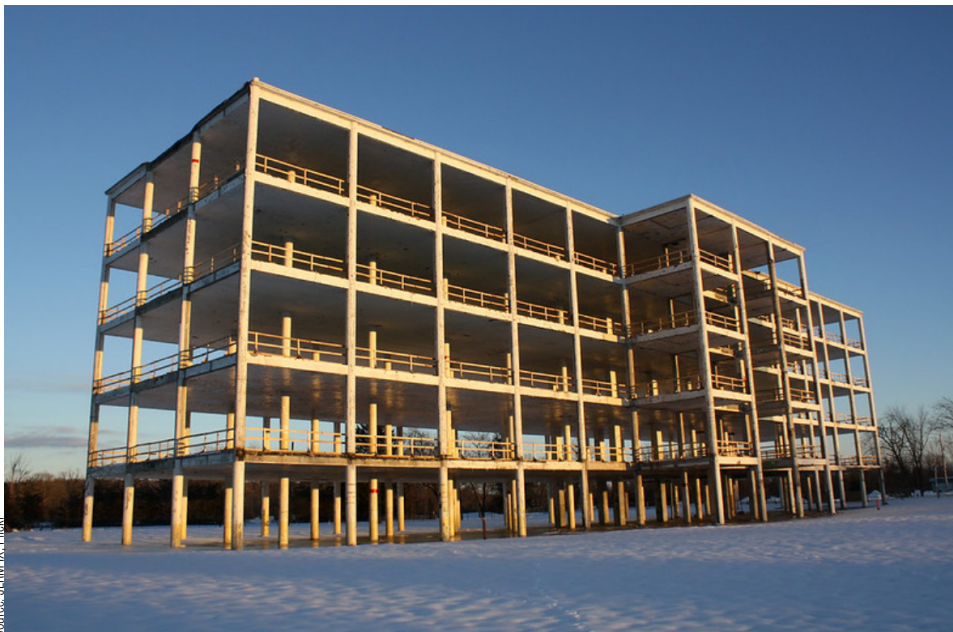
Photo of the Bata Shoe Factory demolition in February 2014, showing exposed building interior and floor slabs<sup>37</sup>.
