Canadian Brownfields Case Study

Colomac Mine Remediation Project

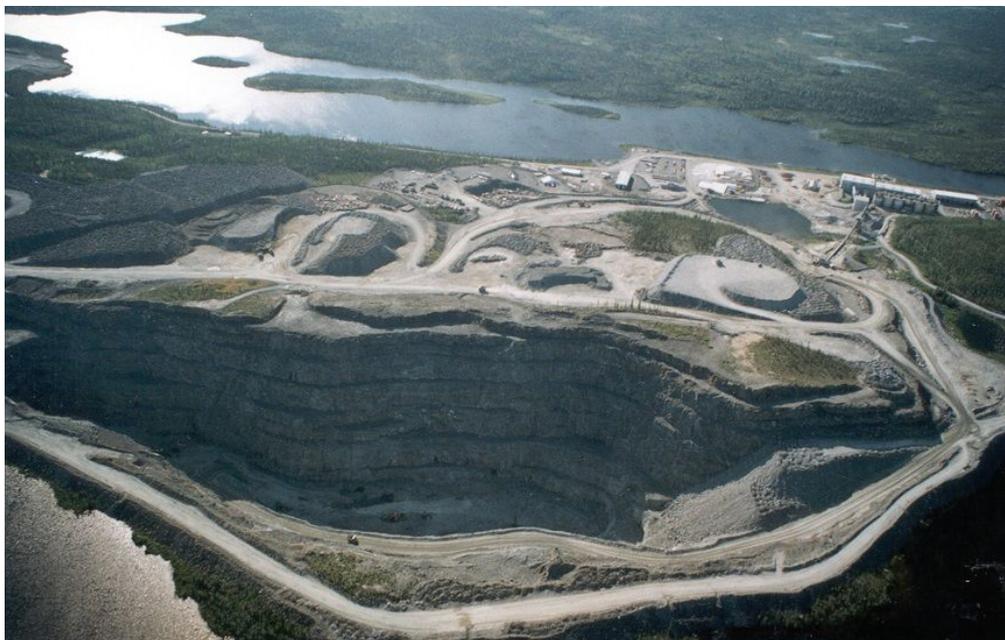
Figure A: Zone Pit 2 empty in 1997 - Source: [https://maps.canada.ca/journal/content-en.html?lang=en&appid=bf1c9c70b8d64f-](https://maps.canada.ca/journal/content-en.html?lang=en&appid=bf1c9c70b8d64f-3da9434edf39&appidalt=800276ab7d5046d5a-088238cac44d8d2&wbdisable=true#wb-cont)

An Enhanced Natural Removal program was implemented in order to contain tailings that were collected at Spruce Lake and Tailings Lake during the operations at the mine. By 1999, Spruce Lake was full of solid tailings and Tailings Lake was near overflowing its dams. As precautionary measures were taken to prevent this overflow, the result showed cyanide and other chemical contamination. Between 2003-2006, the contaminated waters in Tailings Lake and Zone 2 pit (an overflow precaution area)

were treated naturally by adding phosphates in order to promote the growth of algae¹⁰. The use of algae is sustainable and enhances the breakdown of chemicals like cyanide and ammonia¹¹. Algae growth relies heavily on oxygenation of water, so diffusers were installed in Zone Pit 2 to increase and cycle oxygen from varying depths of the water¹².

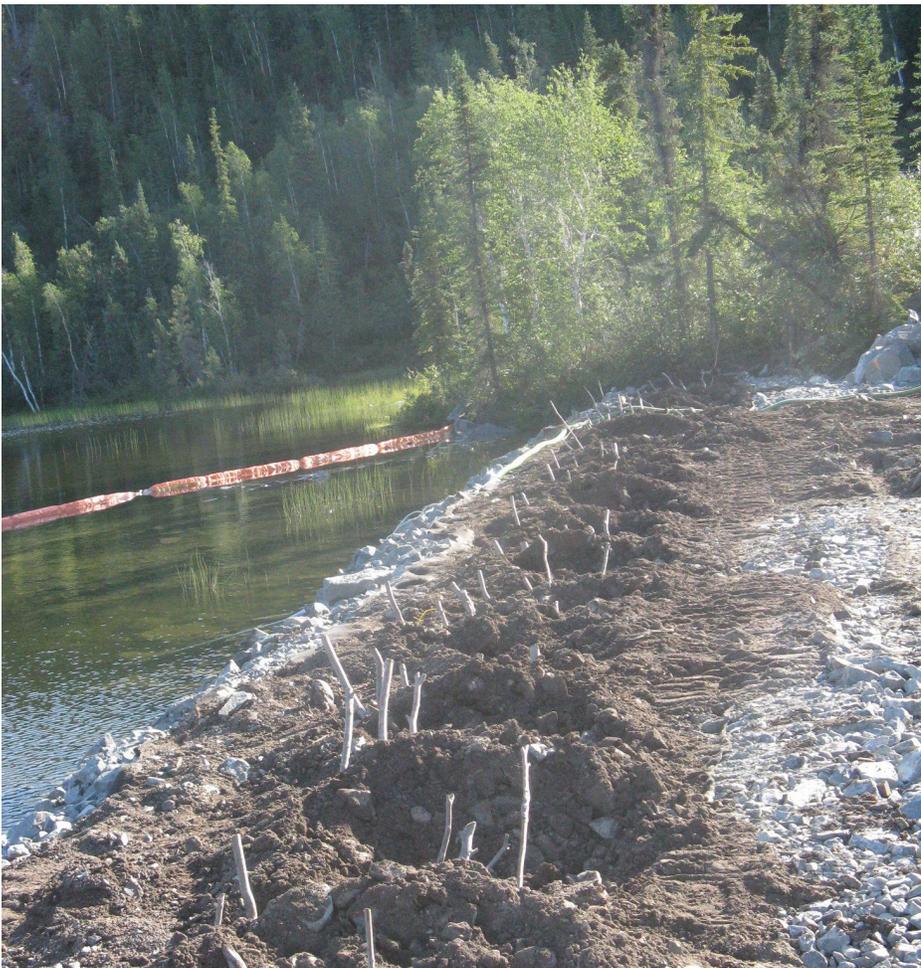
Figure C: re-vegetation along shoreline in August 2010 - Source: <https://maps.canada.ca/journal/content-en.html?lang=en&appid=bf1c9c70b8d64fc1850e3da9434edf39&appid=800276ab7d5046d5a088238cac44d8d2&w=undefined&>

Shoreline restoration was an important area of focus at the site, as contaminants were found in the shallow sediments specifically at Steeves Lake. These contaminants included benzene, ethyl-benzene, xylenes, petroleum hydrocarbon (PHC) and polyaromatic carbons (PAH). Impermeable layers were implemented on the shorelines to create long term solutions to the contamination of Steeves Lake. These layers were composed of waste rocks, geotextile material, infill of gravel, sand and peat and ensured that the parts of the shoreline that were contaminated didn't come into contact with the body of water itself. According to the Fisheries act, the total area available for fish habitat should remain unchanged. Thus, the government had to compensate for the loss in fish habitat by creating them anew. Among various techniques, the planting of native vegetation was used to supplement the growth of aquatic ecology. Highlights of the long term monitoring of these areas include the recording of burbot, slimy sculpin and lake chub downstream and upstream of the Dam 2 Channel, as well as growth of thick vegetation

on the banks of the channel which include willows and sedges planted by workers. A notable 70% of these plantings have survived¹³.
