# Canadian Brownfields Case Study

## Lac-Mégantic Rail Disaster Remediation

### PROJECT SUMMARY

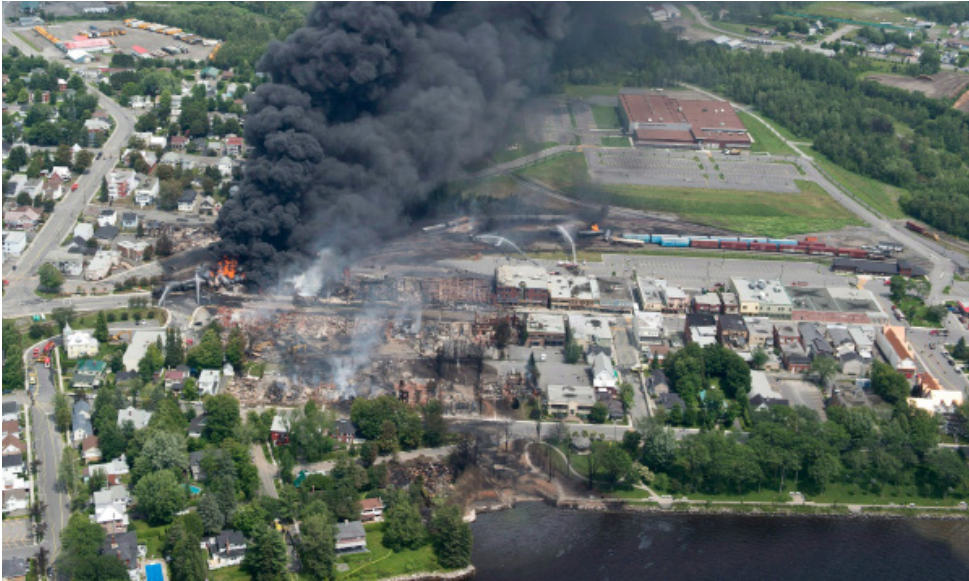
*The Lac-Mégantic downtown core experienced a derailment of crude oil carrying tankers on a heavy rail line running through the city along the lakeshore.*

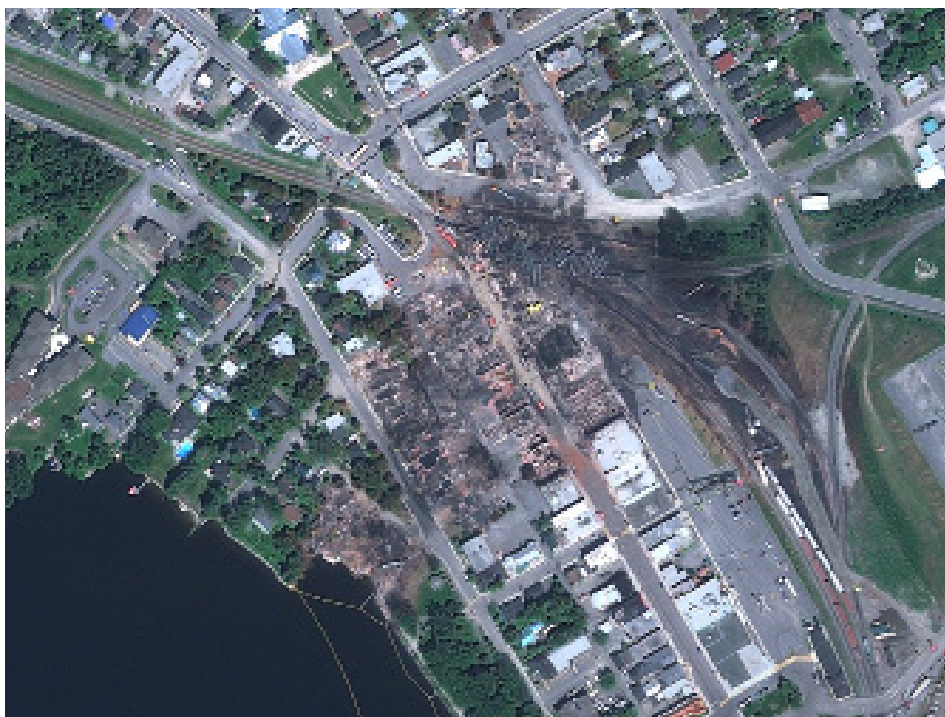
*Destruction of buildings occurred due to fire, explosions, and demolition during the emergency remediation phase.*

The success of the above efforts to prevent contaminant migration is hard to judge. Out of the six million litres of oil spilled, approximately 100,000 litres of petroleum products contaminated the Chaudière River<sup>28</sup>. The initial phase of cleanup was complicated by several factors. Residual heat from the initial fires as well as potential exposure from benzene, a toxic substance contained in crude oil, were reported to hinder cleanup efforts<sup>29</sup>. Such conditions made trenching activities and the demolition of 28 buildings and 55 trees occurring in the first month both dangerous and challenging<sup>30</sup>.

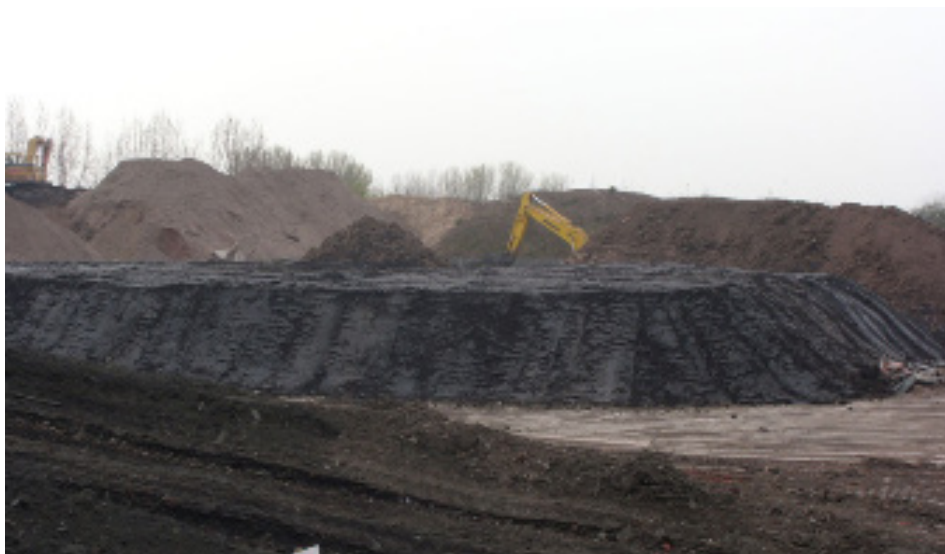
*An example of aerated biopile soil remediation.*

Remediation of contaminated soils and water involved soil excavation and pumping of contaminated water for treatment<sup>37</sup>. Twenty-three excavations were performed in and around the site of the derailment<sup>38</sup>. Approximately 280,000 m<sup>3</sup> of soil contaminated with petroleum hydrocarbons was excavated for treatment<sup>39</sup>. Soils were stored on site, in a nearby municipal industrial lot nearby, and in two nearby municipalities for remediation<sup>40</sup>. Contaminated soils were treated<sup>41</sup> using biopile remediation technologies<sup>42</sup>. Biopile remediation involves using microbes native to local soils, aeration, nutrient supplementation, and moisture control to consume and transform petroleum products<sup>43</sup>. Soils meeting Quebec standards

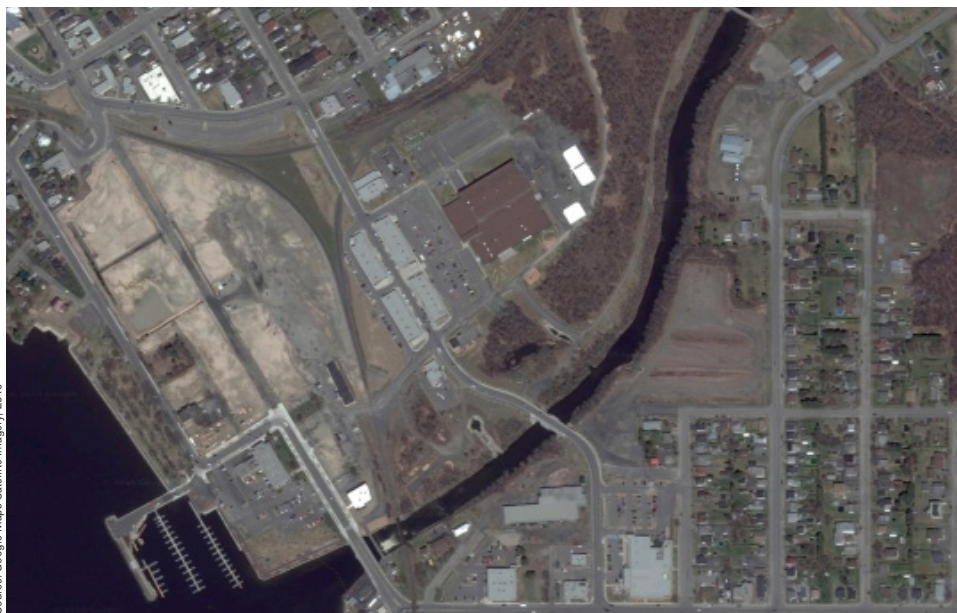
A 2019 photo of the Lac-Megantic derailment site showing the removal of many buildings and lack of redevelopment.

Although soil remediation at the Lac-Megantic disaster site was slated to be complete by 2018, some issues have prevented redevelopment of the site<sup>51</sup>. An analysis of satellite imagery from 2019 shows that no buildings are currently present on the site where significant excavation and remediation with clean fill was performed<sup>52</sup>. Excavation of contaminated soils reached several meters in depth on the site<sup>53</sup>. The sandy quality of soil used as fill on the site has created unstable soil conditions<sup>54</sup>. In order to redevelop
